Causal Analysis Report

Chevron Richmond Refinery
Reportable Flaring Events

February 16, 2020
Flaring Due to Insufficient Recycle Hydrogen

Refinery Flare Event – Cause Investigation Report

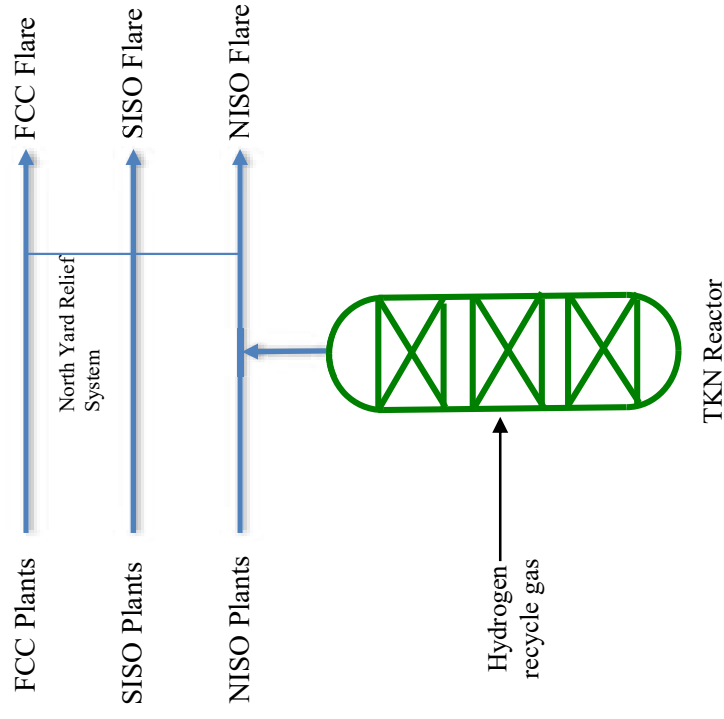
Flaring Due to Insufficient Recycle Hydrogen

On February 16, 2020, a reactor experienced a temperature excursion in the Taylor Katalytic Denitrifier (TKN) Unit of the Hydroprocessing Area Business Unit. The hydrogen recycle gas controller for the reactor was operating in manual control. Operations attempted to control the temperature excursion by making process moves, but there was insufficient hydrogen recycle gas flow during the response. After troubleshooting, the reactor was depressurized to control the temperature excursion, and flaring began at approximately 12:29 AM at the North Isomax (NISO), South Isomax (SISO), and Fluid Catalytic Cracking (FCC) flares. The primary source of vent gas flared during this event was process material from the TKN Unit. Operations immediately began to troubleshoot and made process moves to control the temperature excursion, and flaring stopped at approximately 12:39 AM.

At approximately 12:42 AM, the Automatic Depressurization System (ADS) timer for the reactor activated due to low hydrogen recycle gas flow, and flow was routed to relief. Flaring began at approximately 12:42 AM at the NISO, SISO, and FCC flares. The primary source of vent gas flared during this event was process material from the TKN Unit. Operations immediately began to troubleshoot and manually blocked in the ADS valve at approximately 12:47 AM. As a result, flaring ceased at approximately 12:50 AM.

The sulfur dioxide (SO₂) emissions from the NISO, SISO, and FCC flares exceeded 500 pounds (lbs) on February 16, 2020.
